APOLLO 12

LUNAR SURFACE MAGNETOMETER ANOMALIES

INVESTIGATION OF FAILURE OF ALL SENSOR CHANNELS

SSM-13-1399

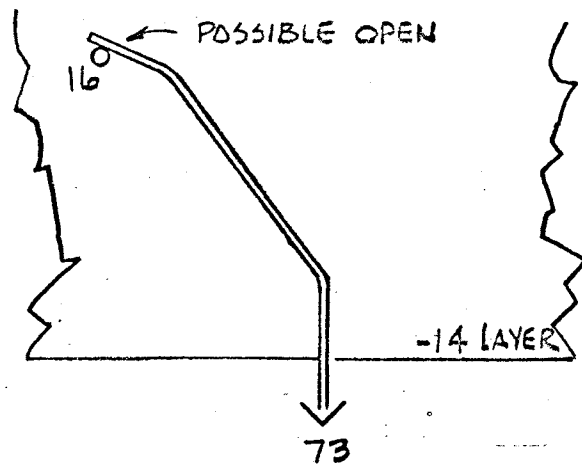
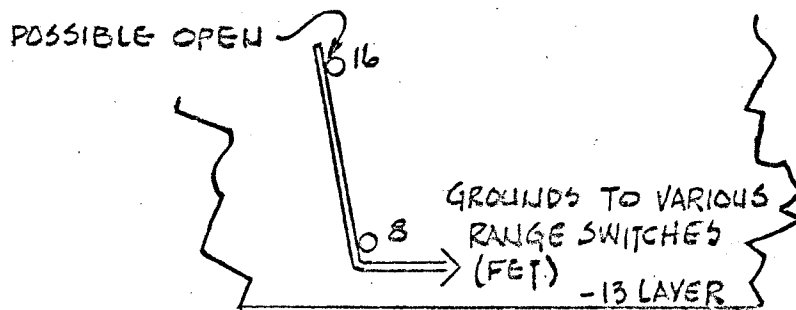
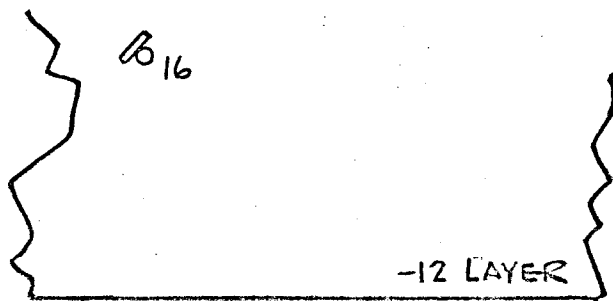
Fig 2 LSM 6 ANOMALY ANALYSIS - DETAIL OF CAL/OFFSET BIAS GEN GROUND

Analysis of the most probable cause of the failure indicates that the open occurred at one of the four welds on the motherboard indicated by x's in Figure 3e and was due to thermal stressing. Experience on the Pioneer Magnetometer and on the LSM program indicates that the preponderance of opens associated with cordwood modules occur at the motherboard connections rather than internal to the potted modules. It is concluded that an open circuit at pin 73 on the A1 motherboard is the most likely cause of failure.

Tests were conducted both on the breadboard model of the Lunar Surface Magnetometer at ARC and LSM S/N 007 at Philco-Ford. In these tests it was possible to duplicate the anomalous condition exactly by opening pin 73 on the motherboard of LSM S/N 007 and the equivalent opening on the breadboard model. By varying the drives to each channel prior to the open, the direction of the channel to saturation positive or negative could be controlled.

A recently adopted procedure for more intense inspection and rejection criteria for motherboard connections is described under 3.4.2. The procedures are effective. Applied to LSM #7, no failures due to opens at the motherboard connections occurred during instrument checkout following assembly, pre-acceptance test and acceptance test.
